Inspection Report

This inspection report prepared specifically for

Betty Buyer
456S Border St.
Wadsworth, OH 44281

Footer To Ridge Property Inspections

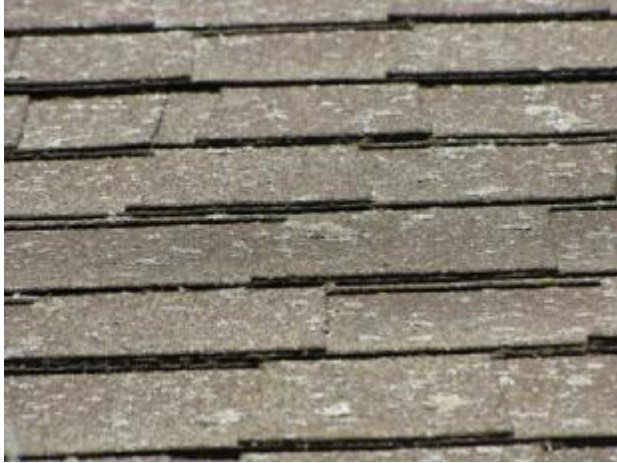
#R1

1. Fungus and mildew growing on shingles, over much of the roof. Recommend reputable contractor evaluate. (see photo 1).

Fungus growing on shingles.

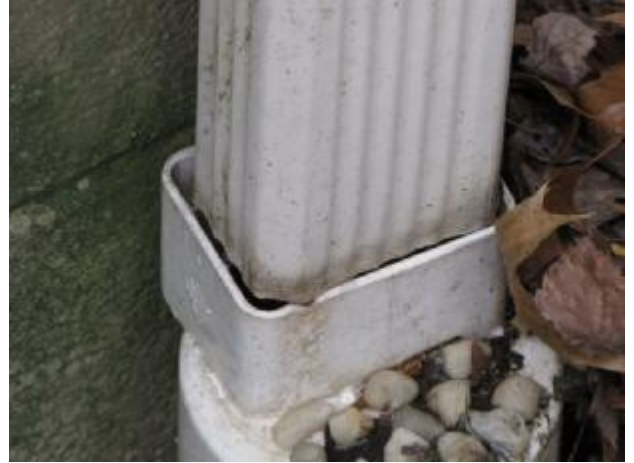
#R2

2. Down spout at back of house near corner of deck and AC unit, not extending down into the drain pipe which will allow water to penetrate to the foundation. Recommend replacing extension. (see photo 2).

Down spout too short.

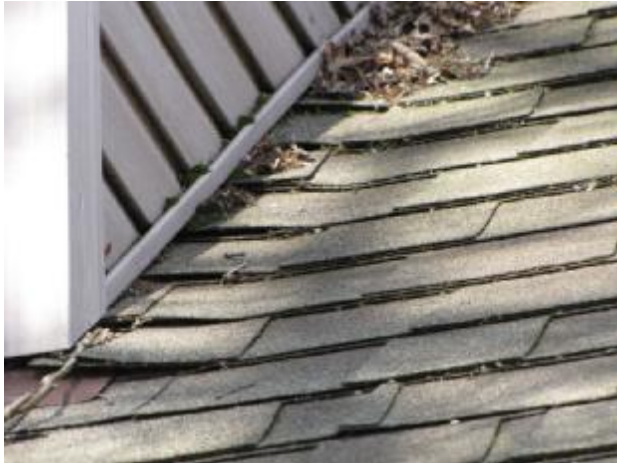
#R3

3. Curling of shingles indicate roof is at mid-life. Recommend reputable contractor evaluate. (see photos 3 and 4).

Shingles curling.

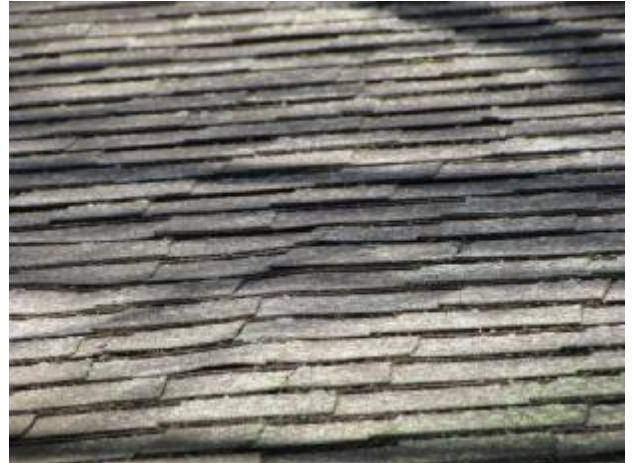
#R4

Shingles curling.

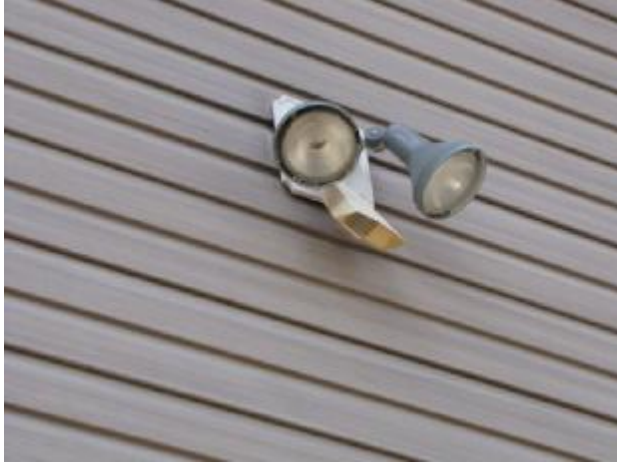
#EX1

Broken security light.

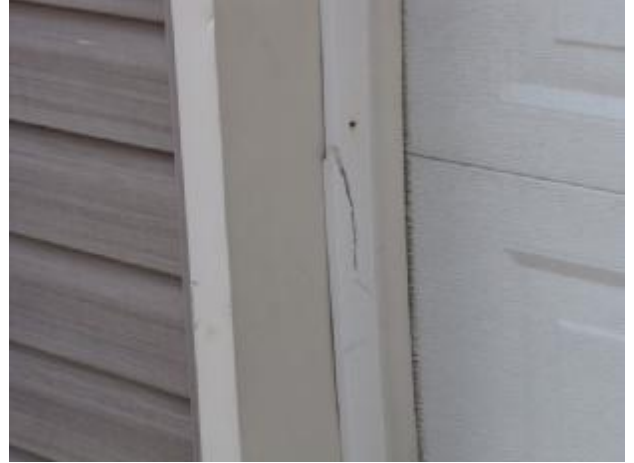
#EX2

Cracked door trim.

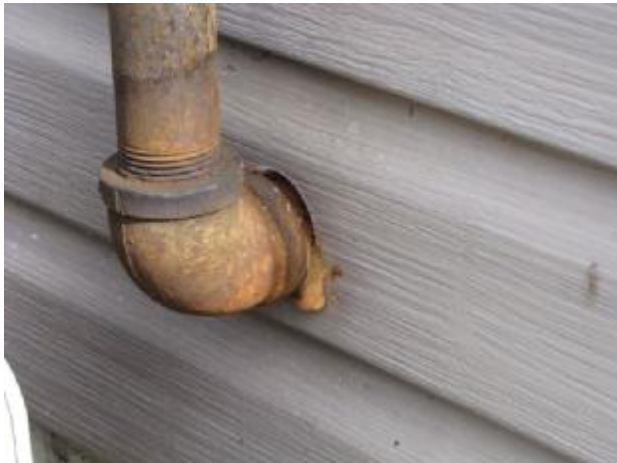
#EX3

Gas line needs caulking.

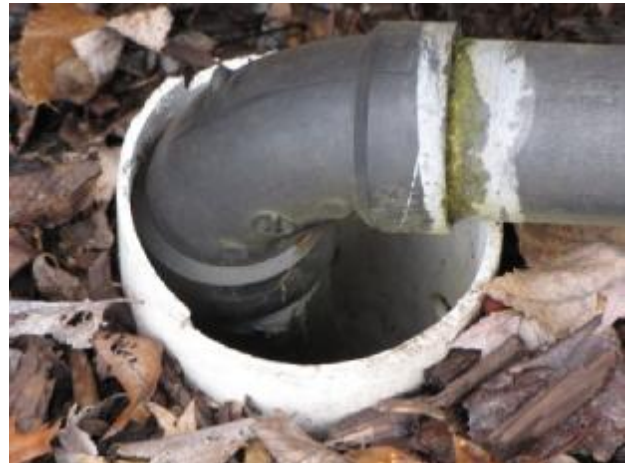
#EX4

Cap missing on sump pump drain.

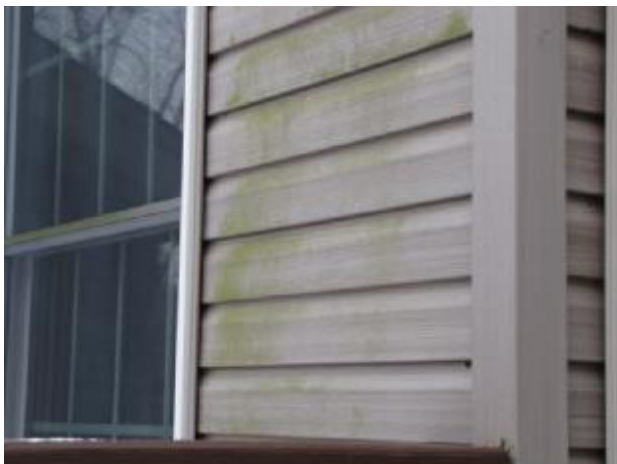
#EX5

5. Fungus growing on vinyl siding on back of house. Recommend cleaning. (see photo 5).

Fungus on vinyl siding.

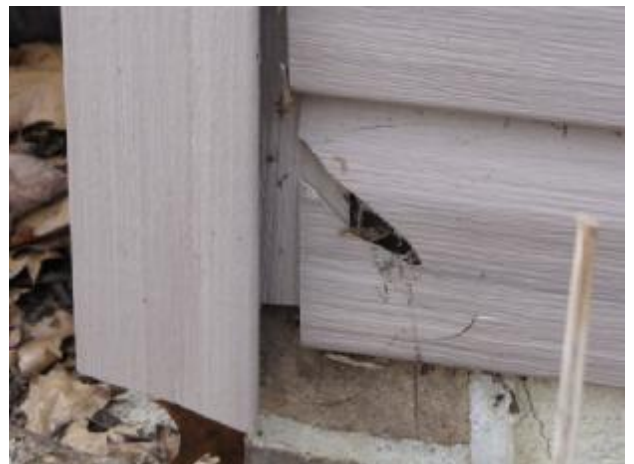
#EX6

6. Vinyl cracked at bottom of rear right corner of garage. This will allow for water and pest infestation. Recommend reputable contractor. (see photo 6).

Vinyl siding cracked.

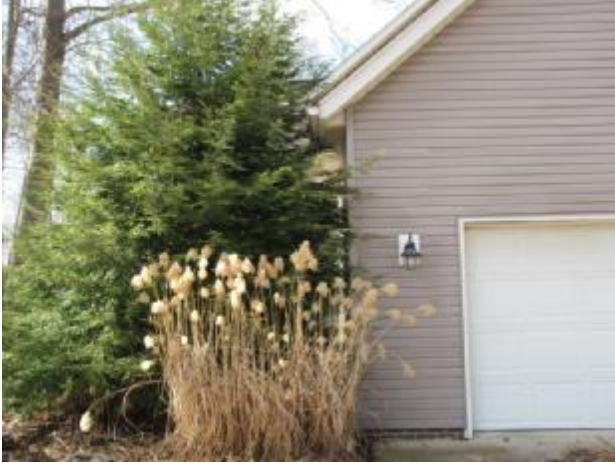
#GD1

1. Tree growing too close to the garage. This will allow for pest infestation. Recommend reputable contractor. (see photo 1).

Tree requires cutting back.

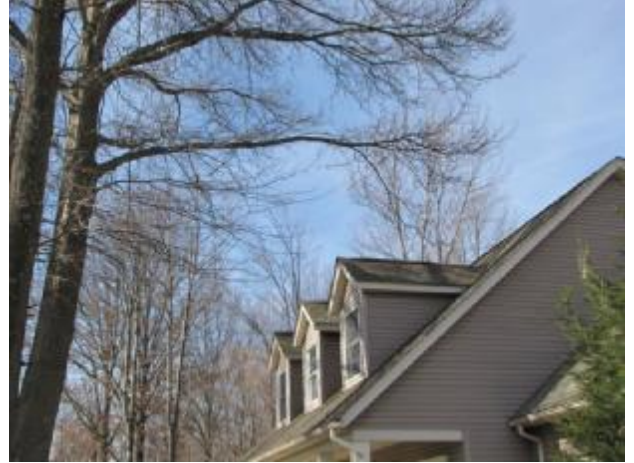
#GD2

2. Large limbs over hanging house should be removed to help deter pest infestation and animals easy access to roof. Recommend reputable contractor. (see photo 2).

Tree requires cutting back.

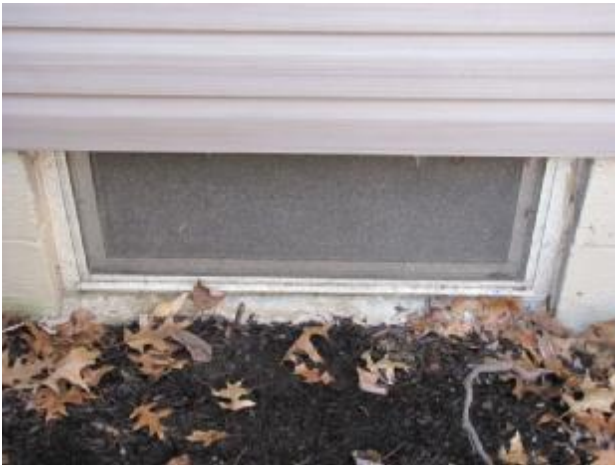
#GD3

3. Landscaping at basement window on back right of house should slope away from the window. This will allow for water penetration to the foundation. Recommend changing slope of landscape and installation of a window well to prevent water from pooling at the window. (see photo 3).

Landscaping is sloping toward basement window.

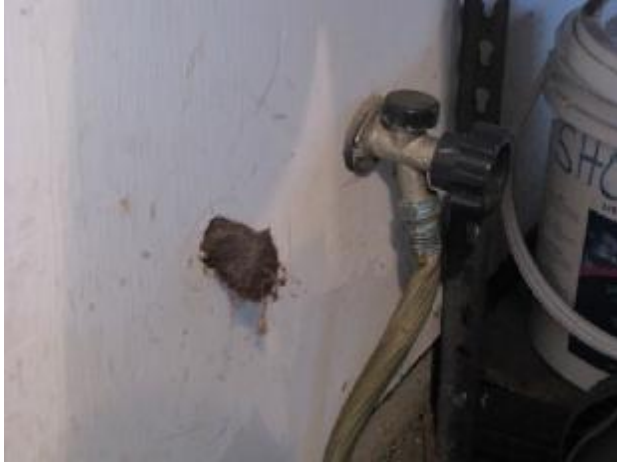
#P1

1. Hot water spigot missing in garage. Recommend reputable licensed contractor. (see photo 1).

Hot water spigot missing in garage.

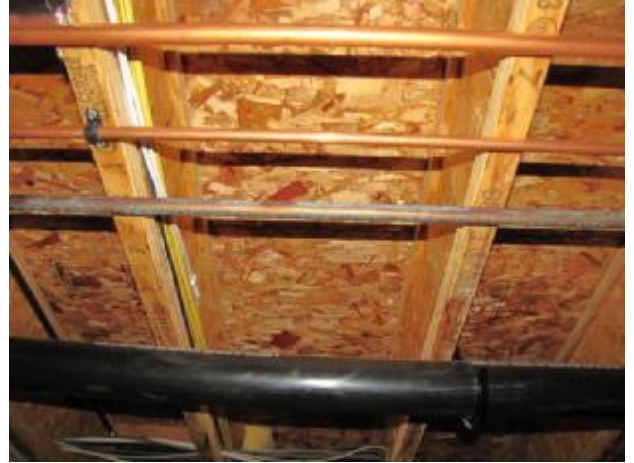
#P2

2. Past condensation on cold water lines. Recommend insulating water pipes and running dehumidifier in the basement. (see photo 2).

Condensation on pipes.

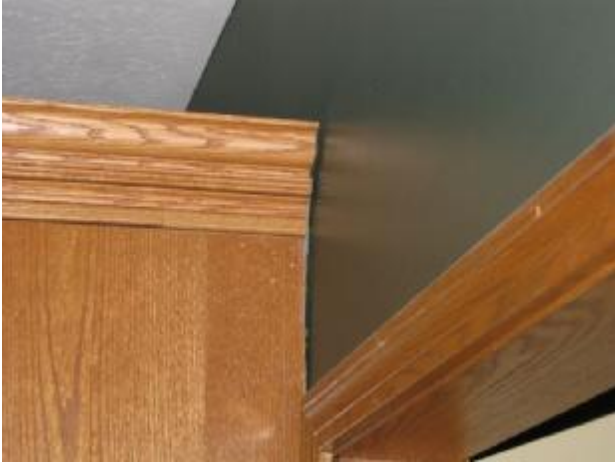
#K1

Cabinet pulling away from wall.

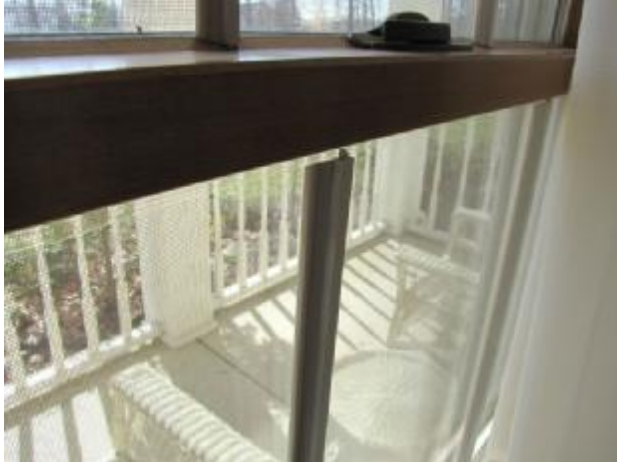
#IR1

1. Plastic window divider (muntins) in the living room has a broken tab. Recommend replacing. (see photo 1).

Window divider (muntin) is broken.

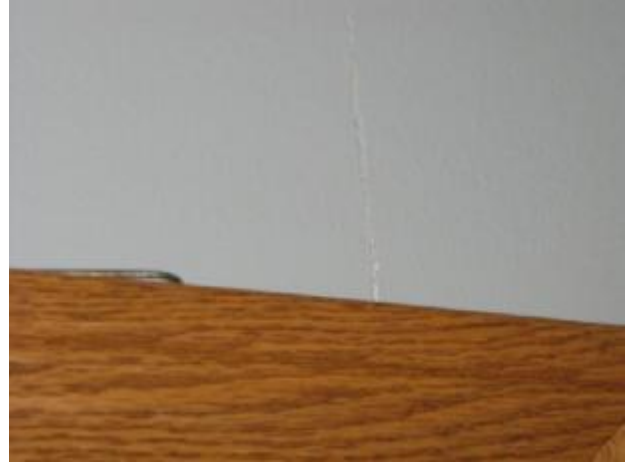
#IR2

2. Settlement crack above master bathroom door. This is normal due to the age of the house. Continue to monitor. (see photo 2).

Crack in drywall.

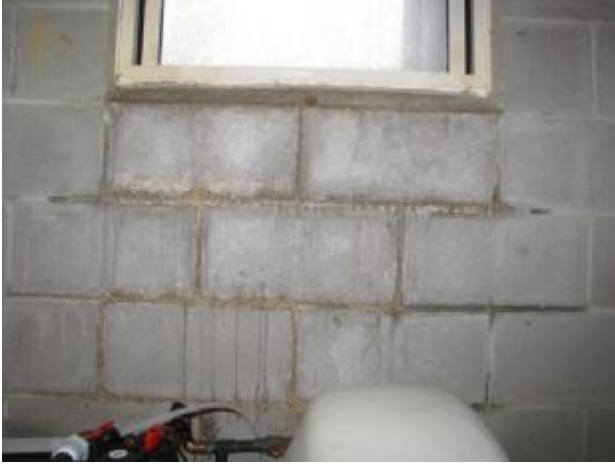
#F1

1. Water is leaking around basement window. Refer back to comment 3 in the Grounds section of this report. Recommend caulking window and install window well on exterior of house. (see photo 1).

Water leak around window.

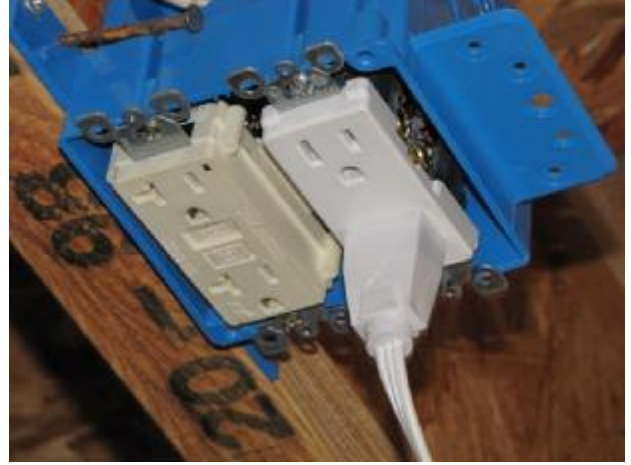
#F2

2. Outlet box in front right corner of basement ceiling is missing a cover plate. Recommend installing a cover plate. (see photo 2).

Outlet missing cover.
